**Subject: Annual Inspection Report
Greensboro Municipal Airport**

ANNUAL INSPECTION REPORT

DECEMBER 21, 2010

GREENSBORO MUNICIPAL AIRPORT
GREENSBORO, ALABAMA

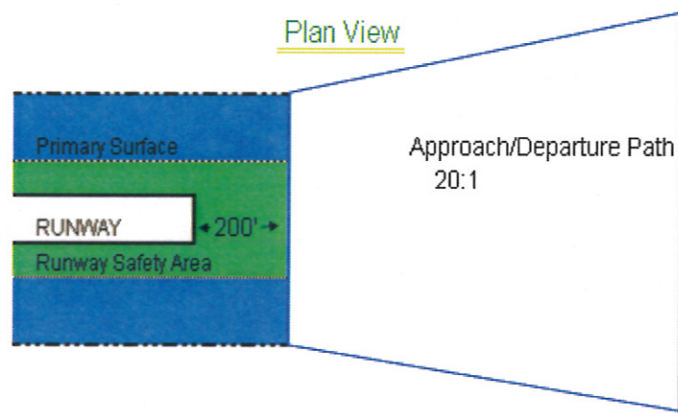
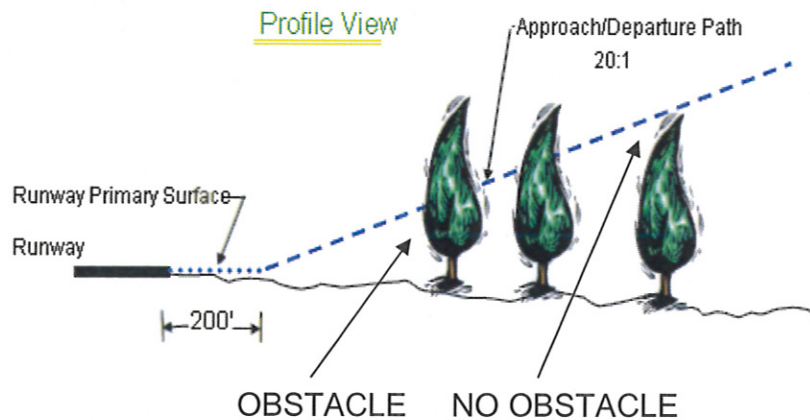
APPENDIX 1

Approach and Departure Path Dimensions			
Inner Width	Outer Width	Length	Acreage
250 Feet	450 Feet	1,000 Feet	8.04 Acres
Primary Surface Dimensions			
250 Feet Wide Centered Along Runway Centerline			
Extending 200 Feet Past the Runway End			
Runway Safety Area Dimensions			
120 Feet Wide Centered Along Runway Centerline			
Extending 200 Feet Past the Runway End
